UNDERWATER BRIDGE INSPECTION REPORT

STRUCTURE NO. 27532

CROW RIVER

DISTRICT 5 –HENNEPIN COUNTY

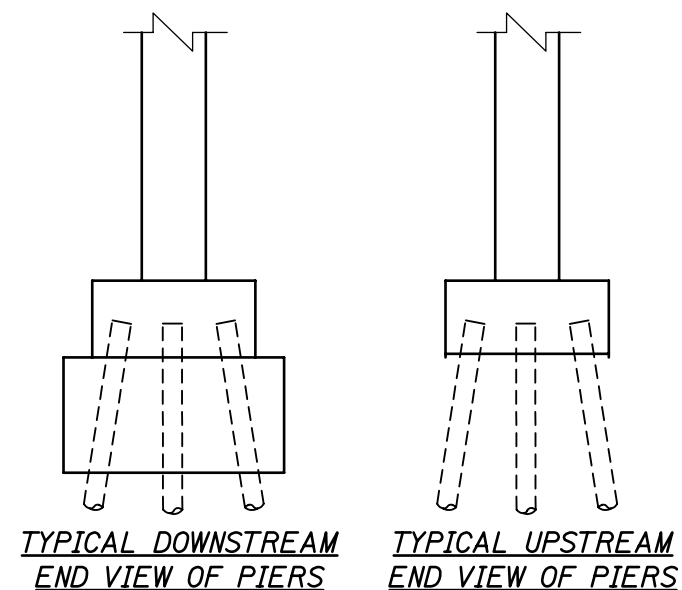
SOUNDING PLAN

- The channel bottom consisted of sandy gravel and 8-inch-diameter riprap with up to 4 inches of probe rod penetration.
- The channel bottom consisted of sandy gravel with up to 4 inches of probe rod penetration.
- The channel bottom consisted of riprap up to 2 feet in diameter.
- A scour depression, 0.5 feet deep and 3 feet in radius, was observed at the upstream end of Pier 1.
- The footing was exposed along the north face of the downstream section of Pier 1 with up to 1 foot of vertical face exposure.
- The footing was exposed at the upstream nose of the downstream portion of Pier 2 with up to 5 inches of vertical face exposure.
- A minor accumulation of timber debris, with pieces up to 6 inches in diameter, was observed at the upstream nose of the downstream portion of Pier 2.

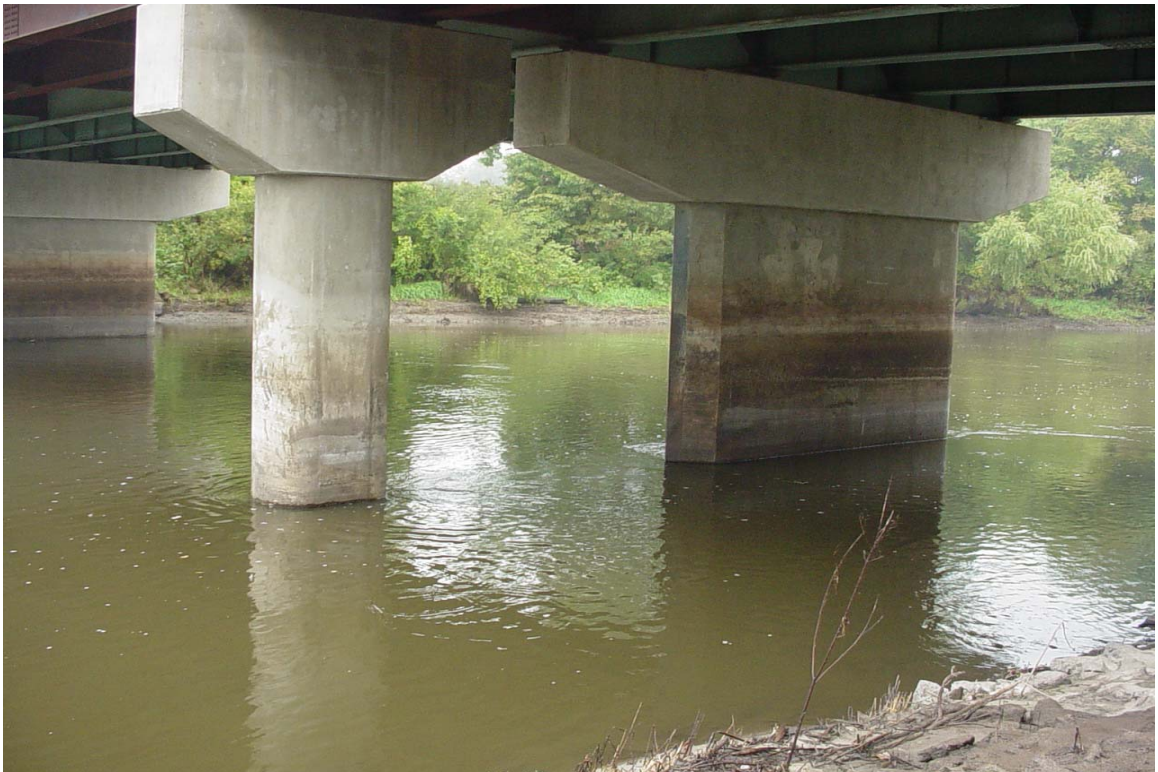
Photograph 2. View of Pier 1, Looking Northeast.

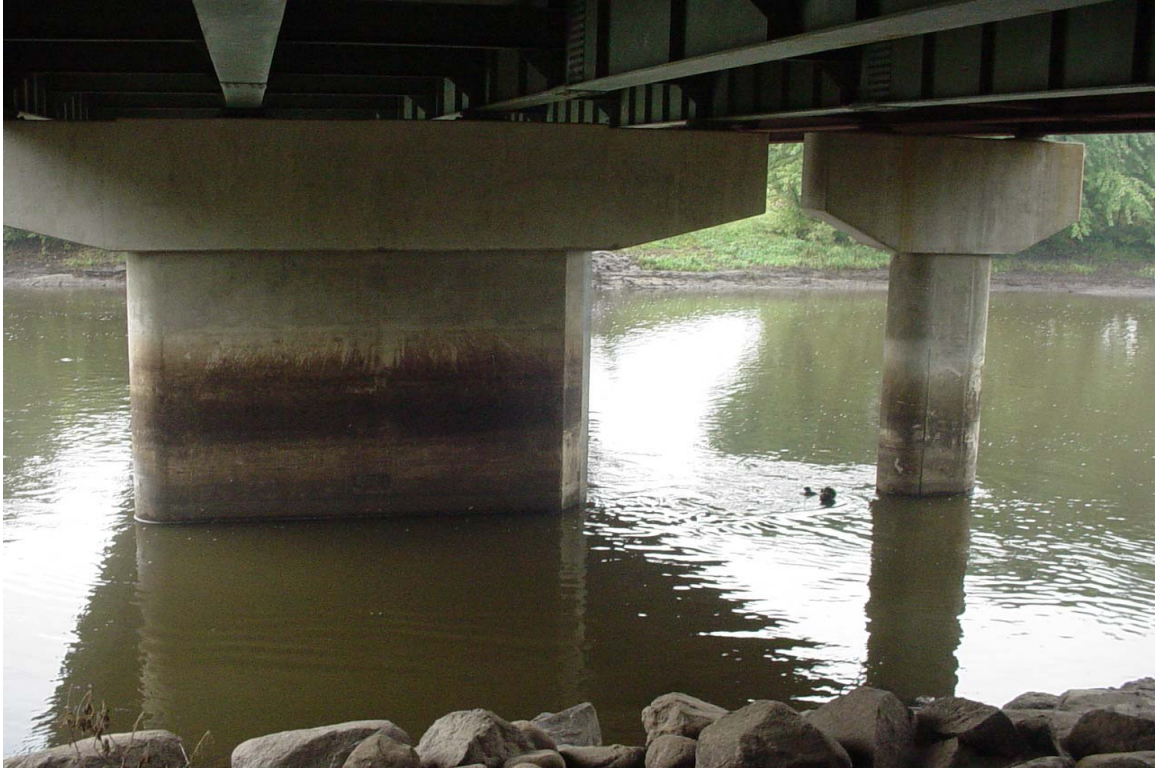
Photograph 3. View of Pier 2, Looking South.

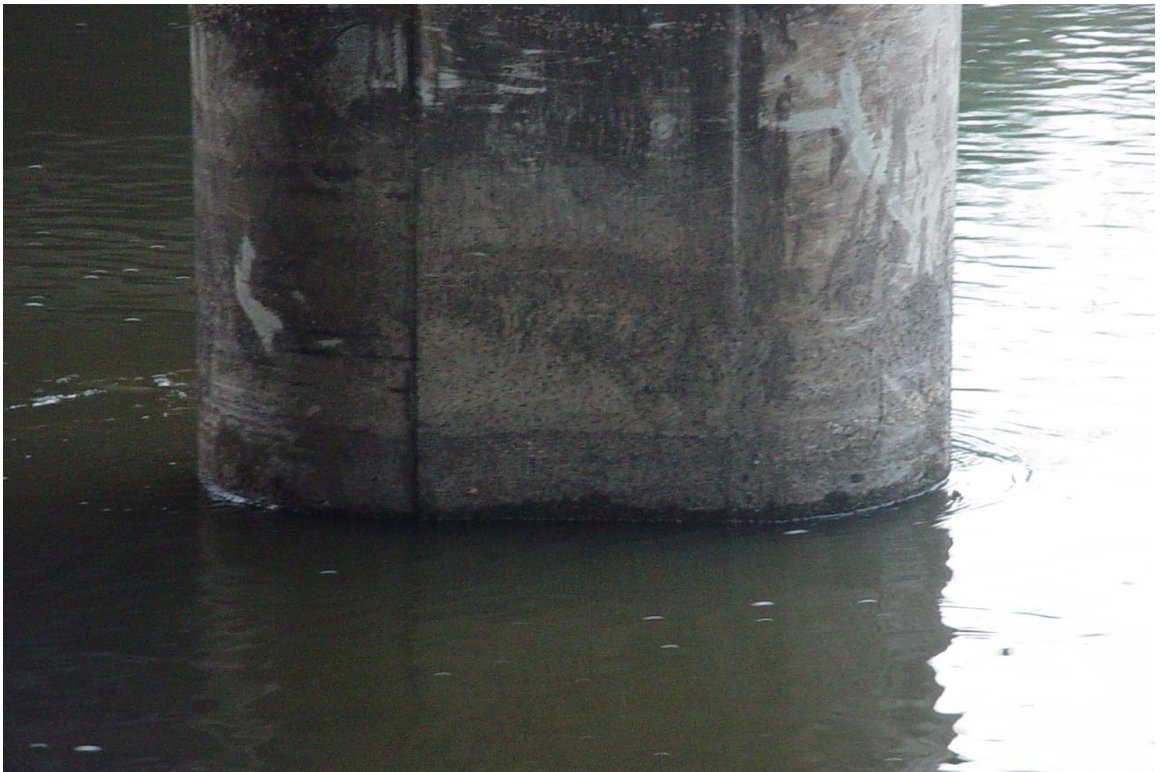
Photograph 4. View of New Upstream Shaft of Pier 2, Looking South.
